SANDIA NATIONAL LABORATORIES,
TONOPAH TEST RANGE, TELESCOPE
REPAIR AND OFFICE BUILDING

HAER No. NV-XXXX

PHOTOGRAPHS
WRITTEN HISTORICAL AND DESCRIPTIVE DATA

HISTORIC AMERICAN ENGINEERING RECORD
SANDIA NATIONAL LABORATORIES, TONOPAH TEST RANGE
TELESCOPE REPAIR AND OFFICE BUILDING
(Building 03-56)

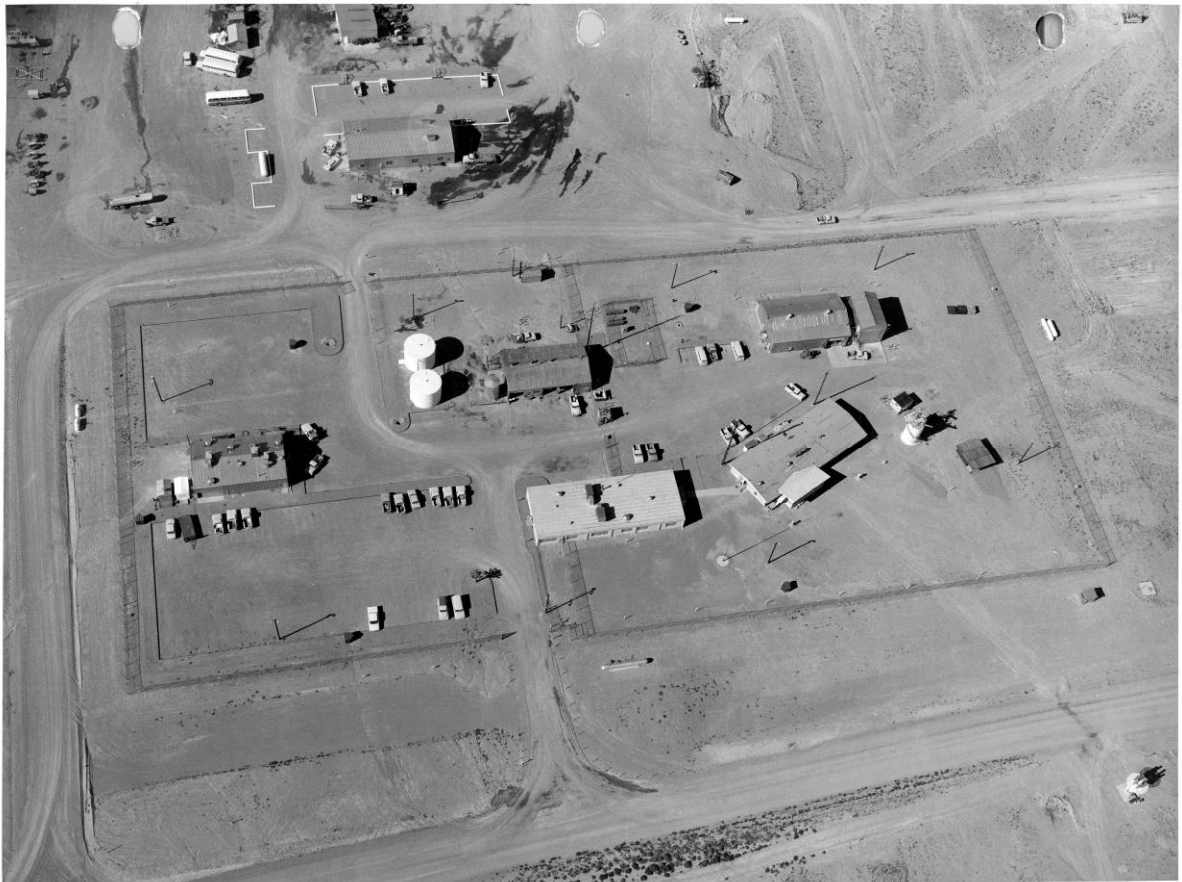
Figure 3 Photographer unknown. 1961
TONOPAH TEST RANGE, CONTROL POINT (AREA 3); AERIAL
PHOTOGRAPH WITH NORTH TO RIGHT; BUILDING 03-56 NOT
CONSTRUCTED YET, WILL BE LOCATED ON NORTH (RIGHT)
EDGE OF AREA

In 1960, a machine shop (03-54), welding shop (03-62), and an additional storage structure (03-66) were added, as well as a few miscellaneous small storage facilities. Two approximately 8,000-gallon water tanks (03-32 and 03-33) were installed. A communication lab was built to the south of Area 3. The communication lab included the radio shop (03-65), storage structure (03-66), and a telephone pole tower for mounting communications equipment and antennas (Figure 3).

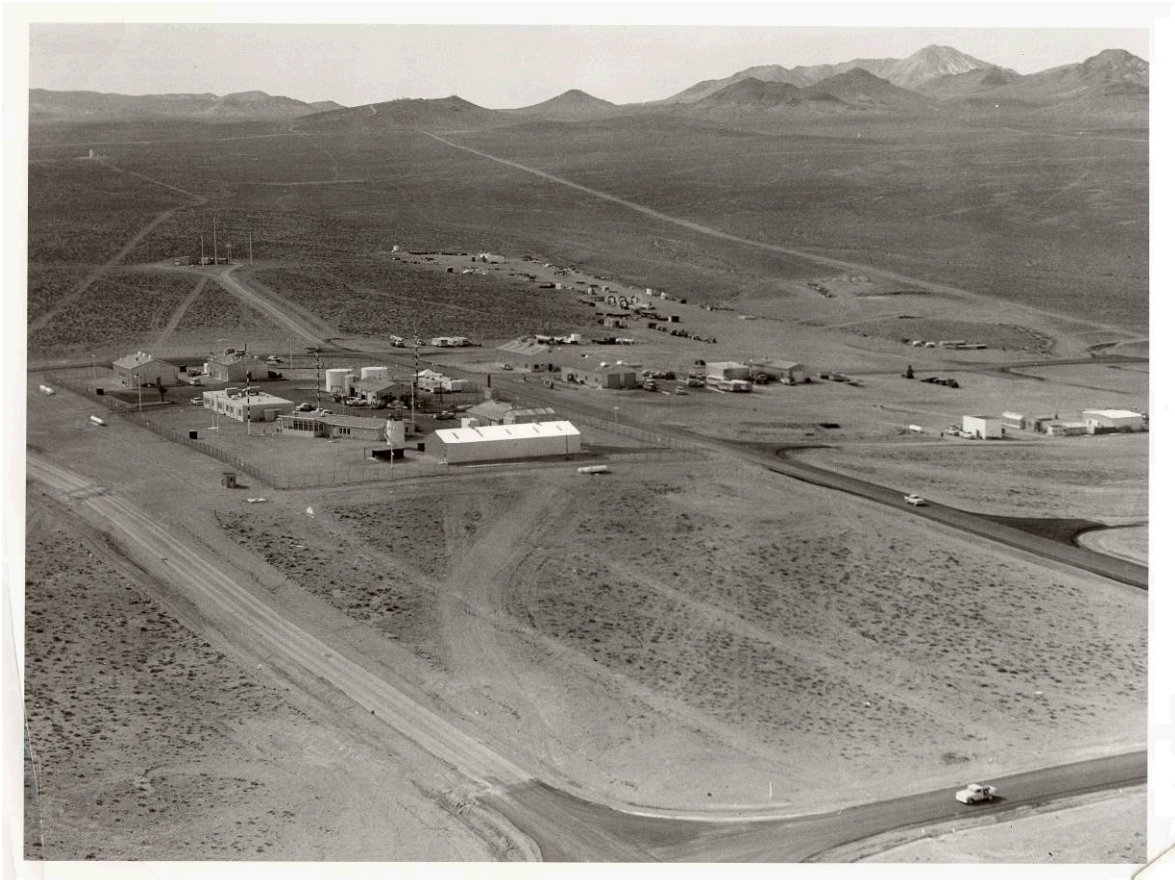
Figure 6 Photographer unknown. Ca. 1967.
TONOPAH TEST RANGE, AREA 3; AERIAL PHOTOGRAPH WITH
SOUTH AT TOP LEFT; BUILDING 03-56 LOCATED ALONG NORTH
(BOTTOM) EDGE OF AREA; LARGE METAL BUILDING
APPEARING WHITE IN THE PHOTOGRAPH

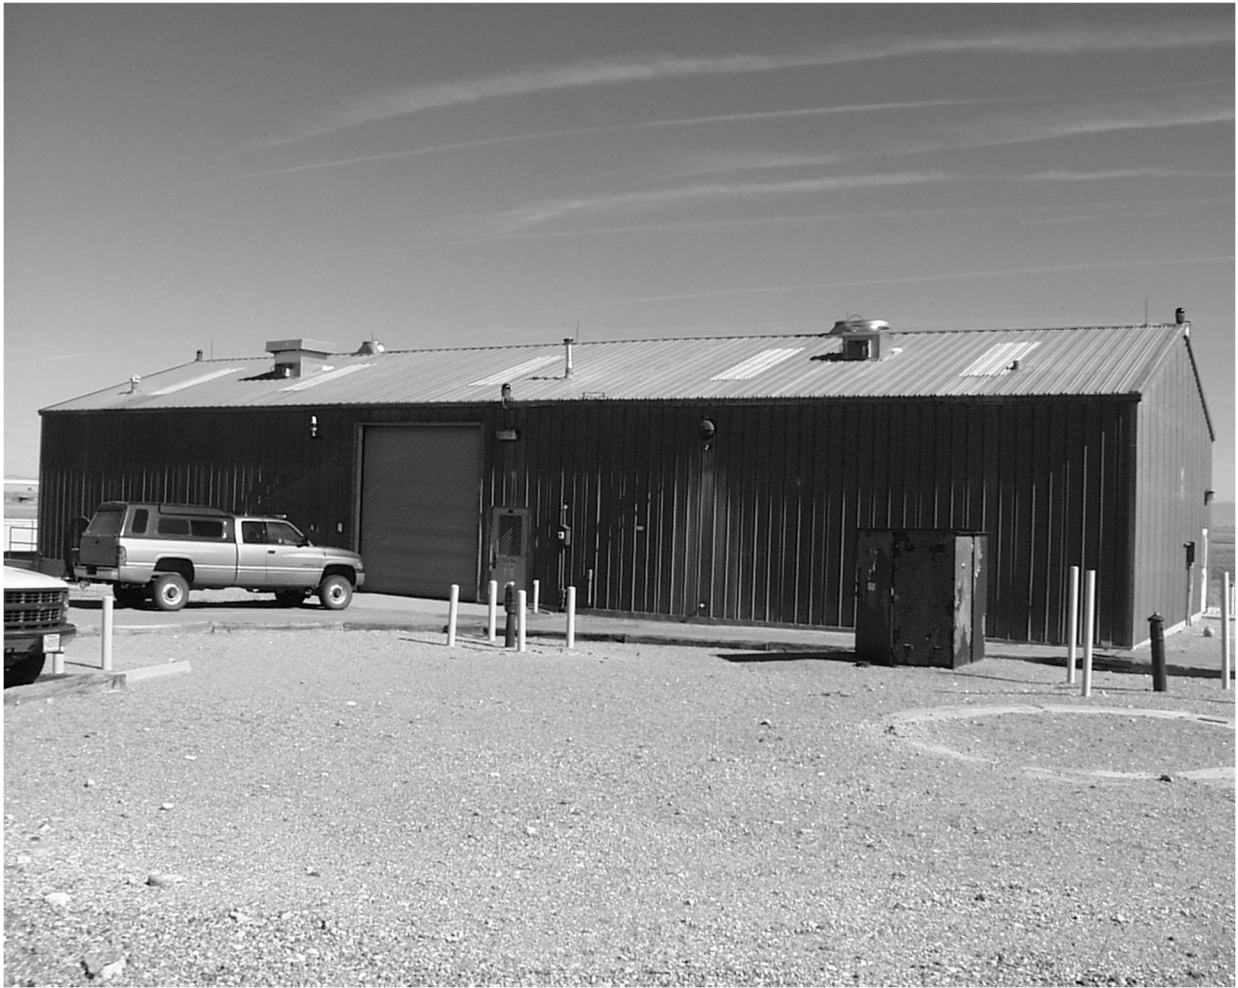
Figure 11 Claire Blackburn, photographer. March 25, 2009.
BUILDING 03-56; SOUTH SIDE OF BUILDING; CLEARED AREA
AND PARKING ON SOUTH SIDE OF BUILDING; FACING
SOUTHEAST

The exterior walls of the building are vertical ribbed steel panels (Figures 8, 9, 11, 12, 13).

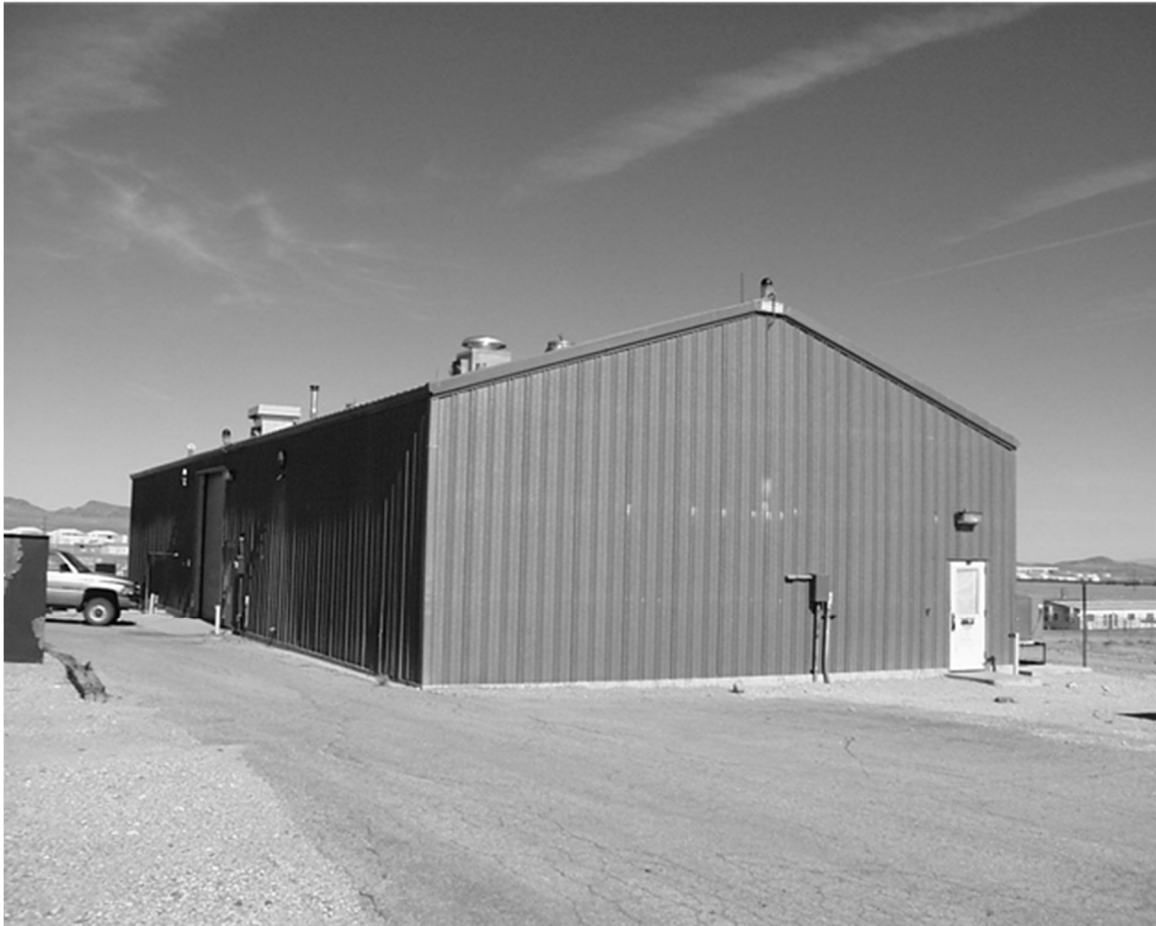
Figure 12 Claire Blackburn, photographer. March 25, 2009.
BUILDING 03-56; SOUTH SIDE AND EAST END OF BUILDING;
CLEARED AREA AROUND BUILDING; FACING SOUTHEAST

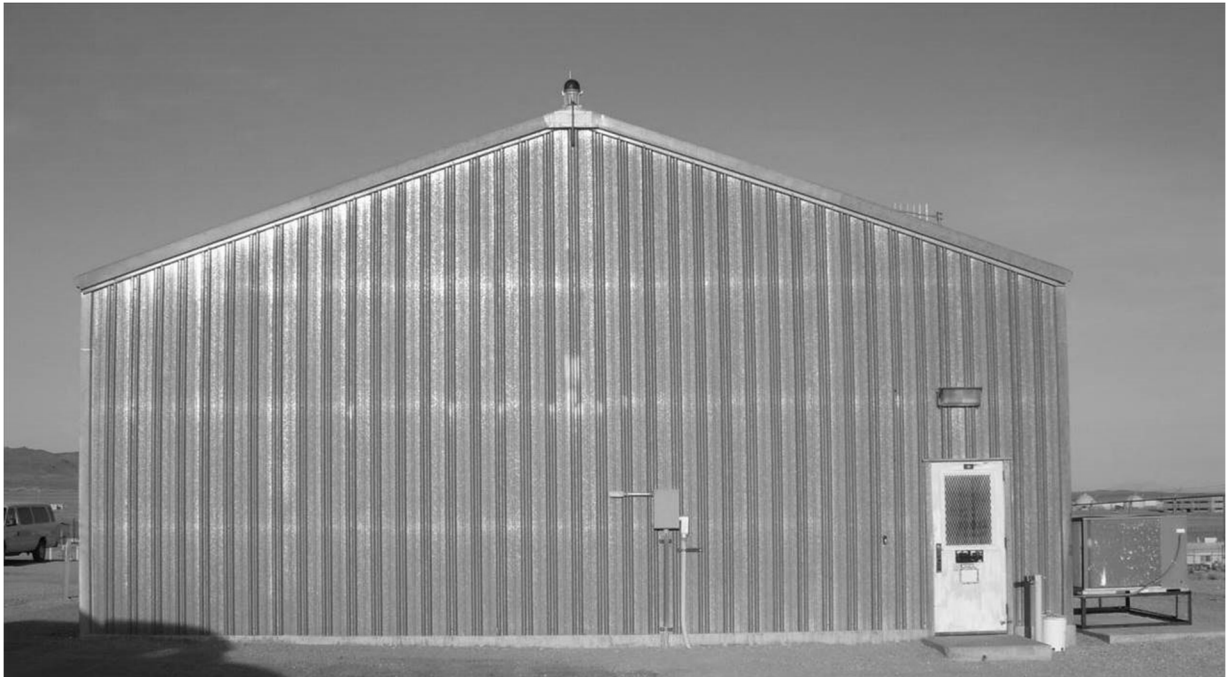
Figure 13 Claire Blackburn, photographer. March 25, 2009.
BUILDING 03-56; EAST END OF BUILDING WITH PEDESTRIAN
DOOR INTO OFFICE SECTION; LIGHTNING WARNING SYSTEM
LIGHT ON ROOF; FACING EAST

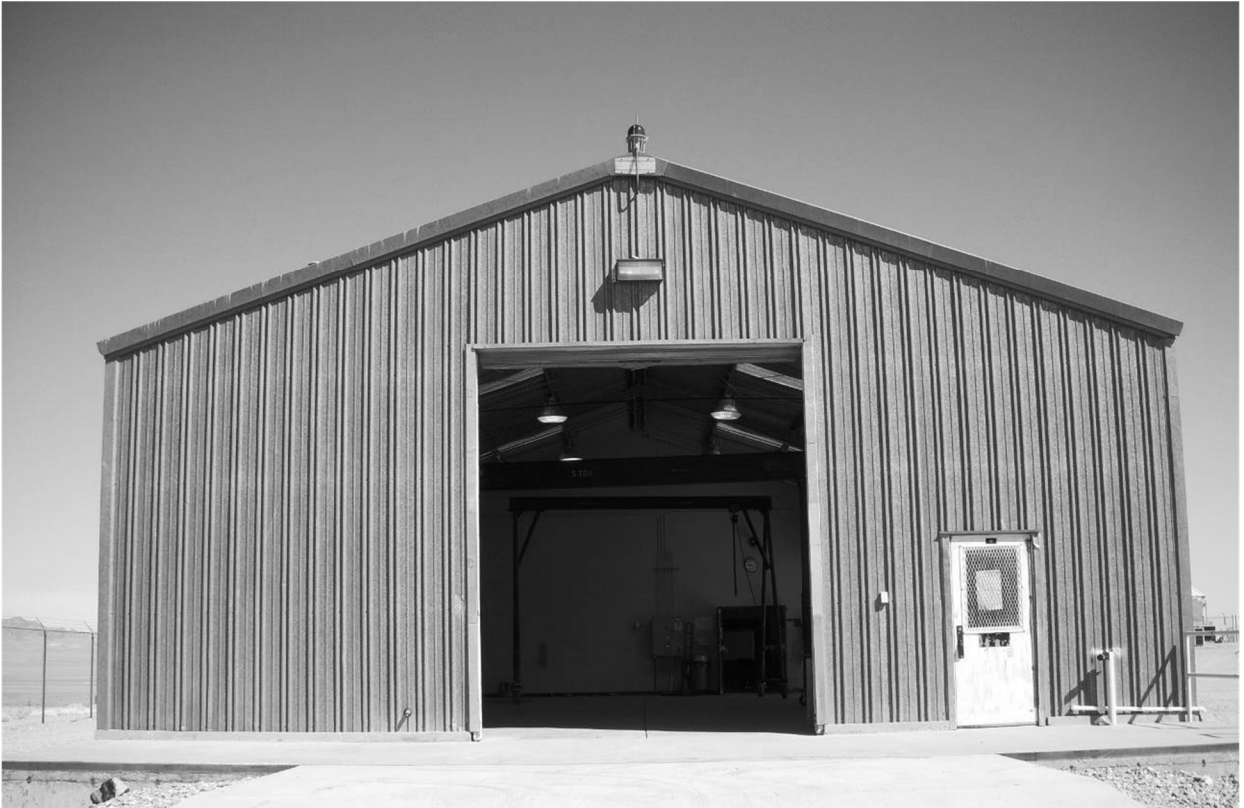
Figure 14 Claire Blackburn, photographer. March 24, 2009.
BUILDING 03-56; WEST END OF BUILDING WITH ROLL-UP DOOR
OPEN; PEDESTRIAN DOOR ON RIGHT; LIGHTNING WARNING
SYSTEM LIGHT ON ROOF; CONCRETE DRIVEWAY UP TO
LOADING DOCK LEVEL; FACING WEST

The building has no porches, stoops, balconies, porticoes, or bulkheads. It does have a poured concrete loading dock on the west end. The area west of the loading dock was graded to bring the soil up to the loading dock level and a poured concrete driveway leads to the dock and the roll-up door on the west end (NV-XXXX-2; Figure 14).

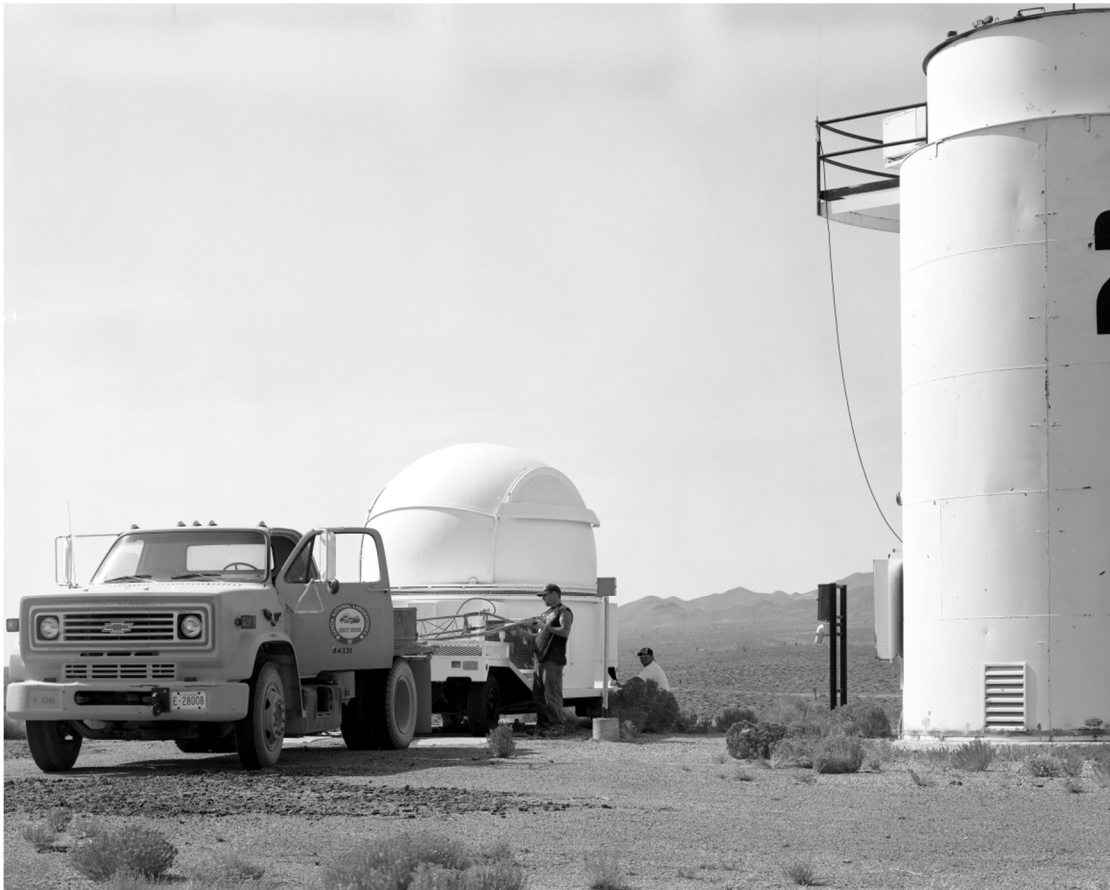
Figure 16 Jim Galli, photographer. July 15, 2004.
TONOPAH TEST RANGE; MOVING MOBILE CONTRAVES ONTO
PAD AT STATION 22; NEAR OLD CONTRAVES TOWER 22 IN USE
PRIOR TO INTRODUCTION OF MOBILE CONTRAVES; FACING
NORTHWEST

The building is in the northeast section of Area 3, along the north fence line of the area (NV-XXXX-5, 6). Its mission has not changed over time. In the early years, it received Contraves cinetheodolite parts and systems for repair, largely devoted to keeping the optics working and reliable.⁷ As mobile Contraves systems were introduced and replaced the static towers from 1969 into the 1980s, they were brought into the building as entire units for maintenance and repair (Figure 16).

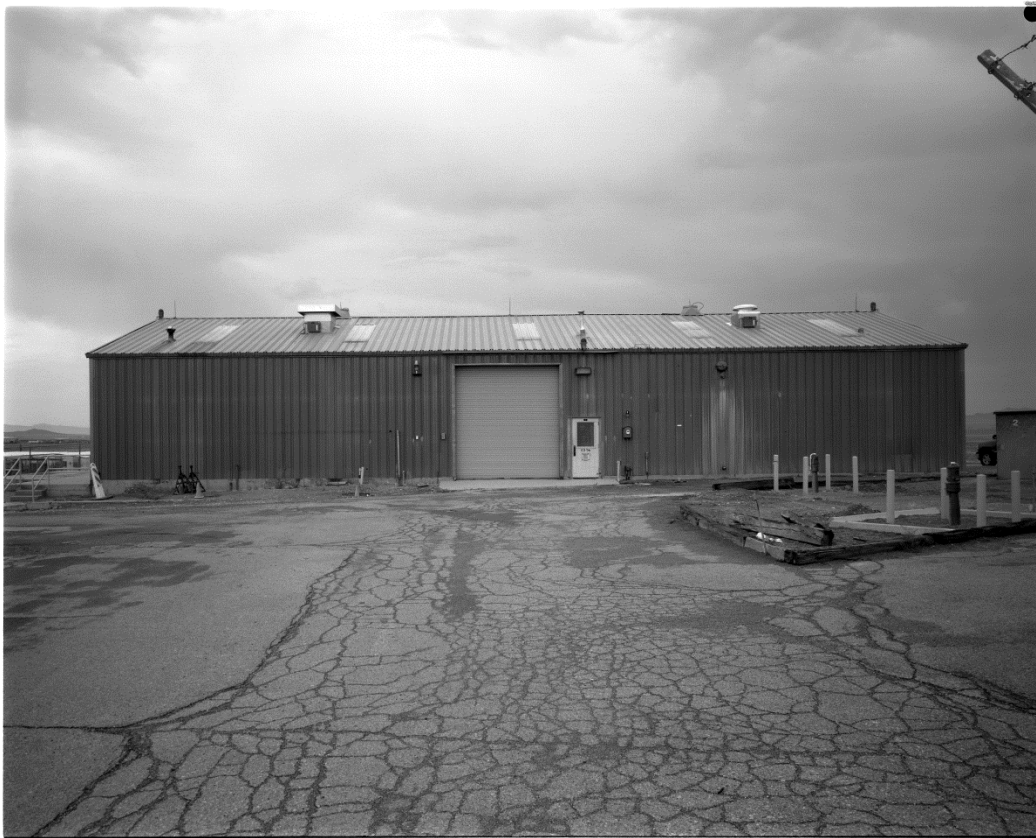
NV-XXXX-1

Joseph M. Bonaguidi, Photographer. August 29, 2005.
SOUTH SIDE OF BUILDING 03-56; PITCHED METAL ROOF
AND SIDES; SKYLIGHT PANELS IN ROOF; METAL ROLL-
UP DOOR INTO HIGH BAY; PEDESTRIAN ENTRANCE INTO
HIGH-BAY; LIGHTNING SYSTEM VISIBLE ON ROOF;
FACING SOUTH

1 ½-story metal steel-framed pre-engineered building on a poured concrete slab foundation. The siding is vertical ribbed metal with no windows; roof is ribbed metal with fiberglass skylight panels. There is a high-bay roll-up door on each of the south and west sides. A metal pedestrian door is located next to each bay door; there is also a metal pedestrian door on the east end. HVAC equipment is located on the north side and on the roof. (NV-XXXX-1, 2, 3)

The building is located on land that slopes down from east to west. The foundation is a reinforced poured concrete slab rising approximately 4" above grade on the east end and approximate 2' above grade at the west end. (NV-XXXX-1; Figure 8)

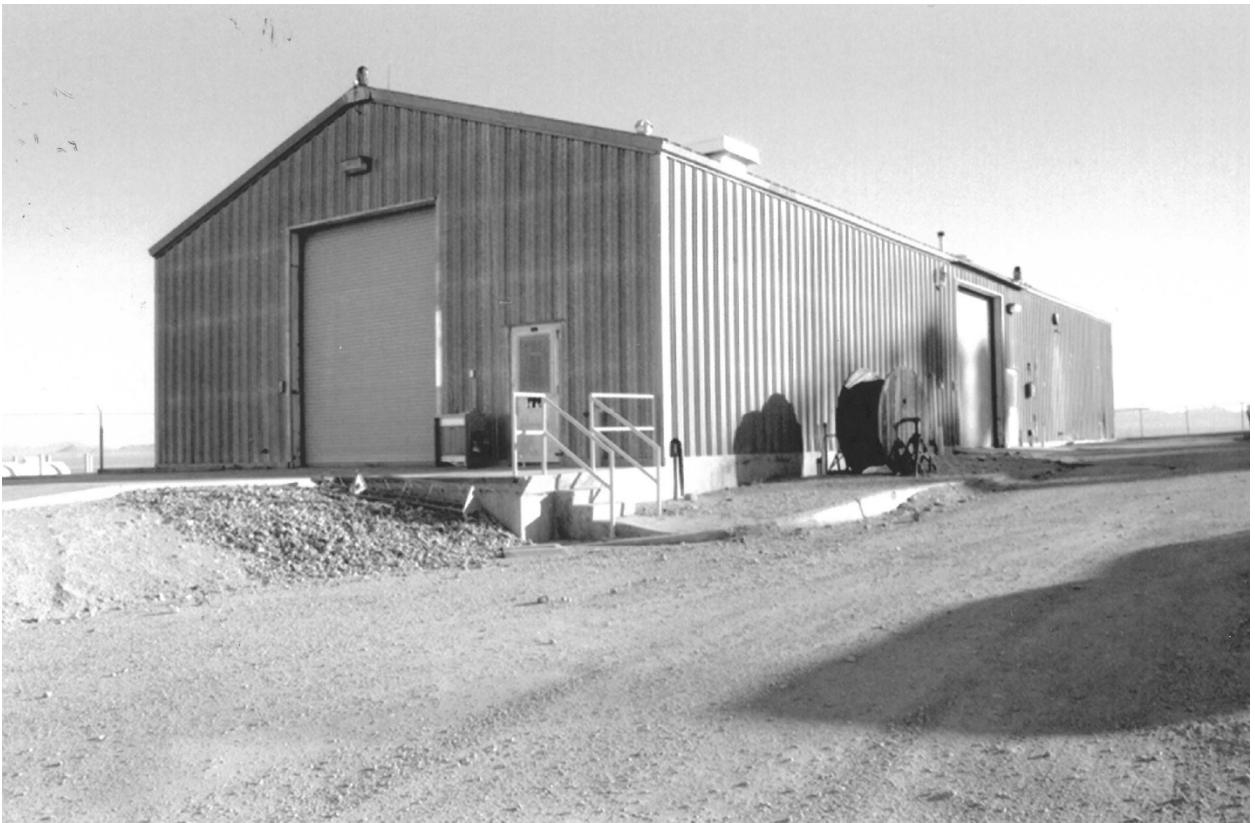
NV-XXXX-2

Joseph M. Bonaguidi, Photographer. August 29, 2005.
WEST END AND SOUTH SIDE OF BUILDING 03-56;
CONCRETE SLAB DRIVE UP TO ROLL-UP DOOR ON WEST
END; PEDESTRIAN DOORS ON WEST AND SOUTH SIDES;
STAIRS TO LOADING DOCK ON WEST SIDE; ROLL-UP
DOOR INTO HIGH-BAY ON SOUTH SIDE; FACING
SOUTHWEST

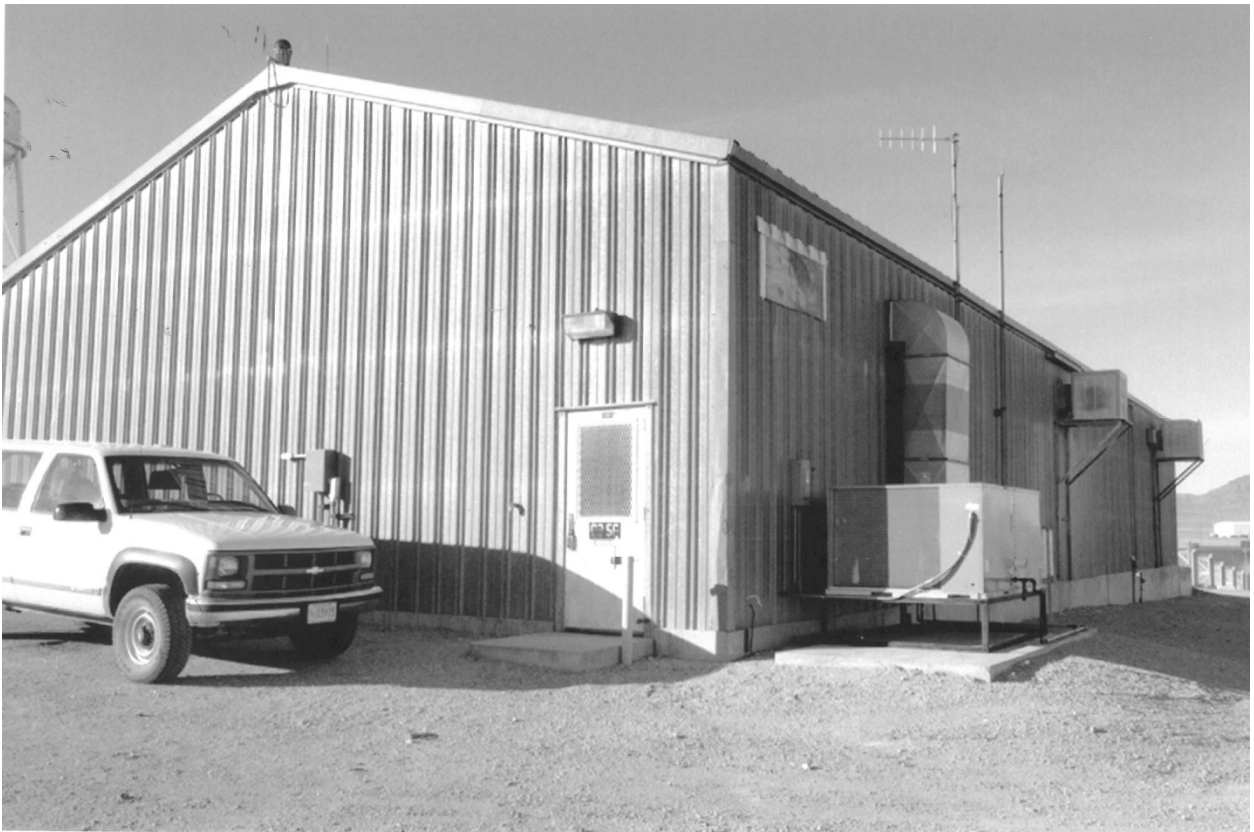
NV-XXXX-3

Joseph M. Bonaguidi, Photographer. August 29, 2005.
EAST END AND NORTH SIDE OF BUILDING 03-56;
PEDESTRIAN DOOR WITH SMALL CONCRETE PAD AT
ENTRY ON EAST END; HVAC DUCTWORK AND UNITS ON
NORTH SIDE; CONCRETE FOUNDATION VISIBLE AS
GROUND SLOPES DOWN TO THE WEST; FACING
NORTHEAST

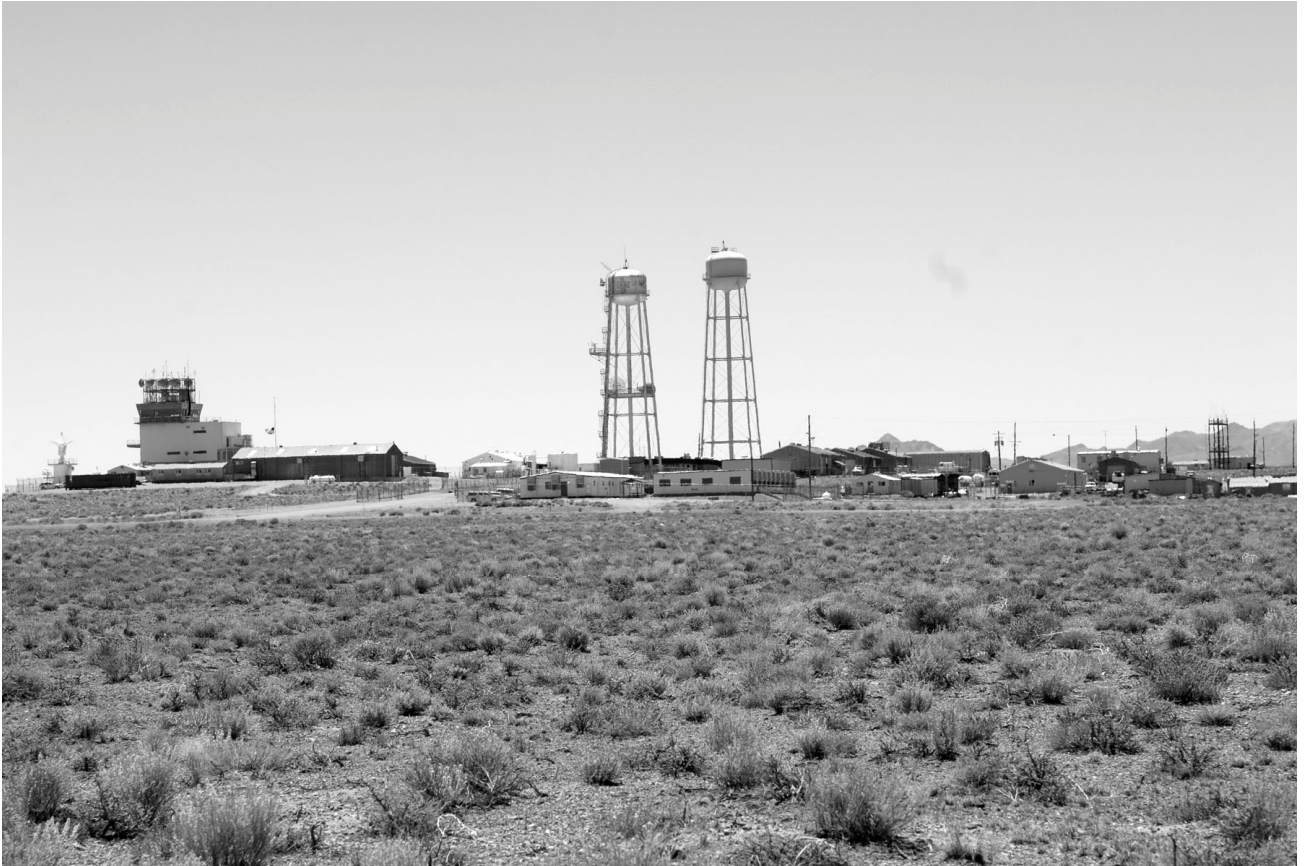
NV-XXXX-4

Jim Galli, Photographer. July 6, 2009.
NORTH SIDE OF CONTROL POINT (AREA 3), TONOPAH
TEST RANGE; BUILDING 03-56 IN LEFT SECTION, IN
FRONT OF (NORTH OF) AND TO RIGHT (WEST) OF
CONTROL TOWER; FACING NORTH

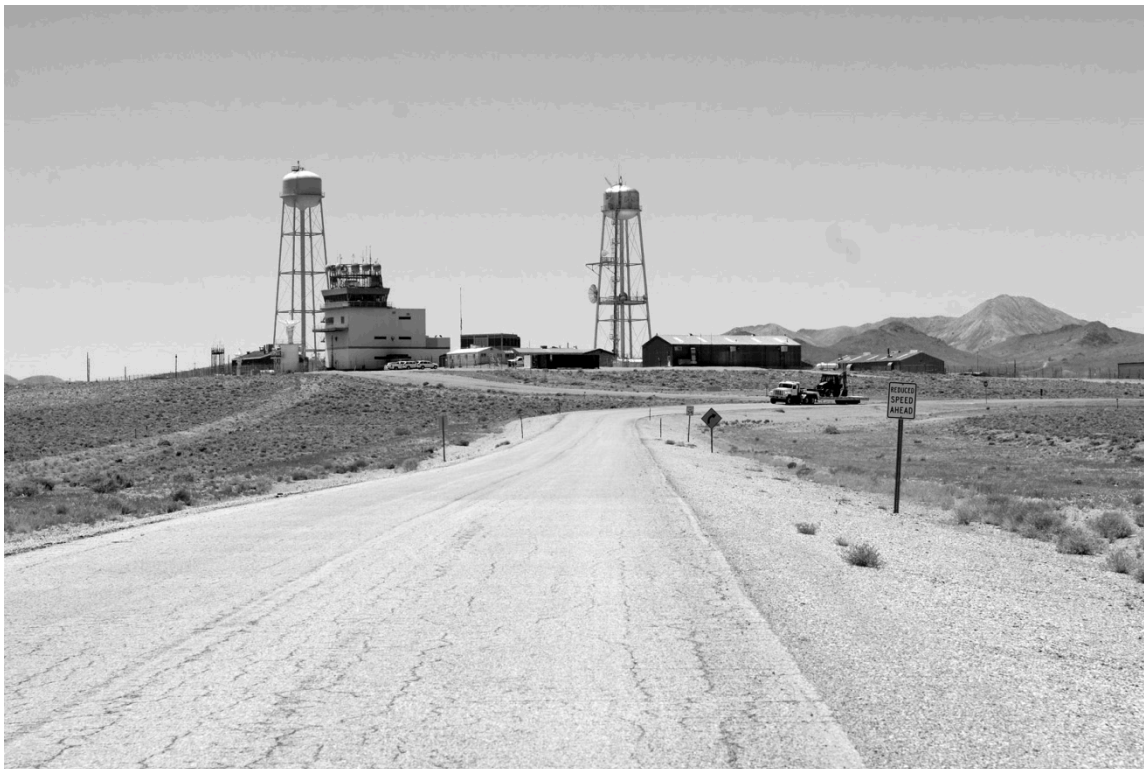
NV-XXXX-5

Jim Galli, Photographer. July 6, 2009.
NORTHEAST SECTION OF CONTROL POINT (AREA 3),
TONOPAH TEST RANGE; BUILDING 03-56 IS LARGE
METAL BUILDING TO RIGHT OF EASTERN (RIGHT)
WATER TOWER; FACING NORTHEAST

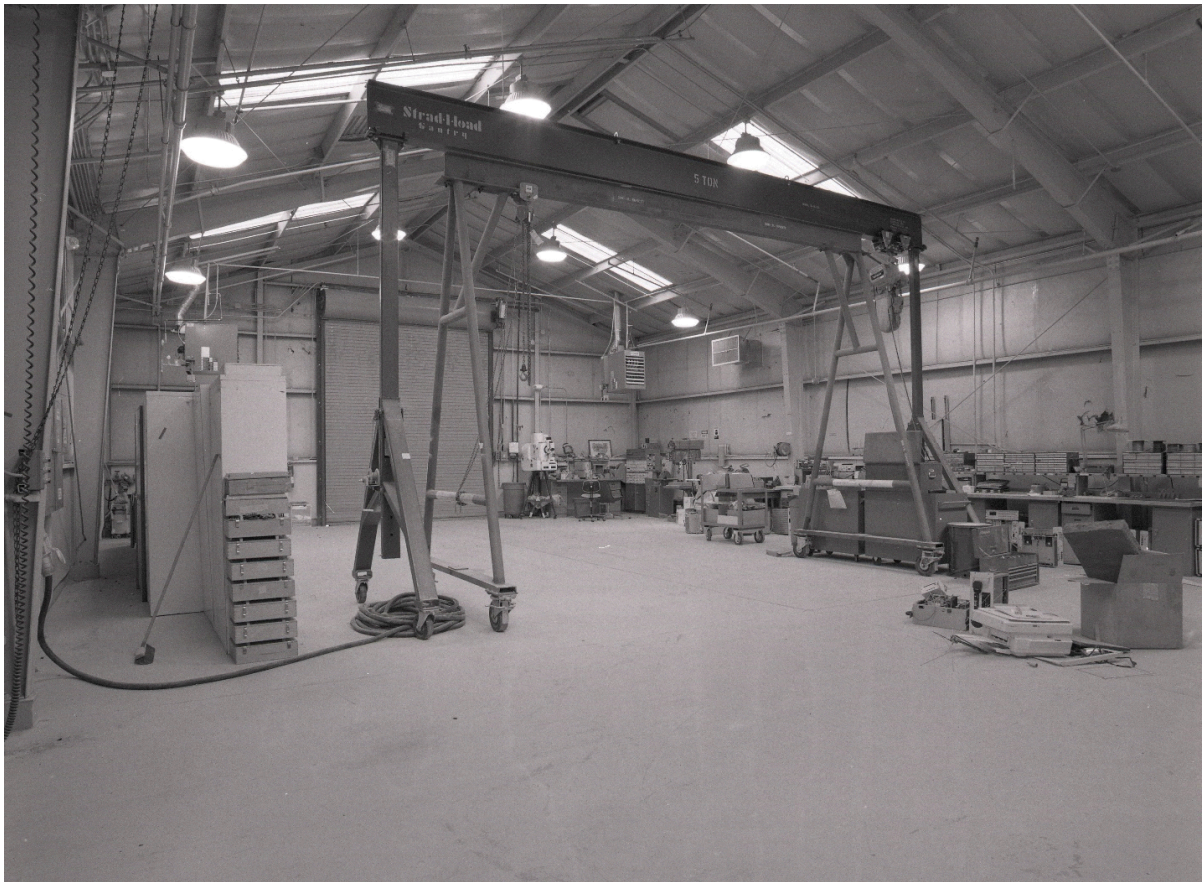
BUILDING 03-56, INTERIOR; WEST AND NORTH WALLS
OF HIGH-BAY; ROLL-UP DOOR TO EXTERIOR ON WEST
WALL; INSULATION VISIBLE THROUGHOUT AS
INTERIOR WALLS ARE NOT FINISHED; SKYLIGHTS IN
ROOF; SUSPENDED LIGHTS; MOVABLE 5-TON CRANE
FRAME; OPEN WORKSPACE; FACING SOUTHEAST

This is a steel-framed building. Framing is visible in the high-bay interior (NV-XXXX-6, 7, 8, 9).

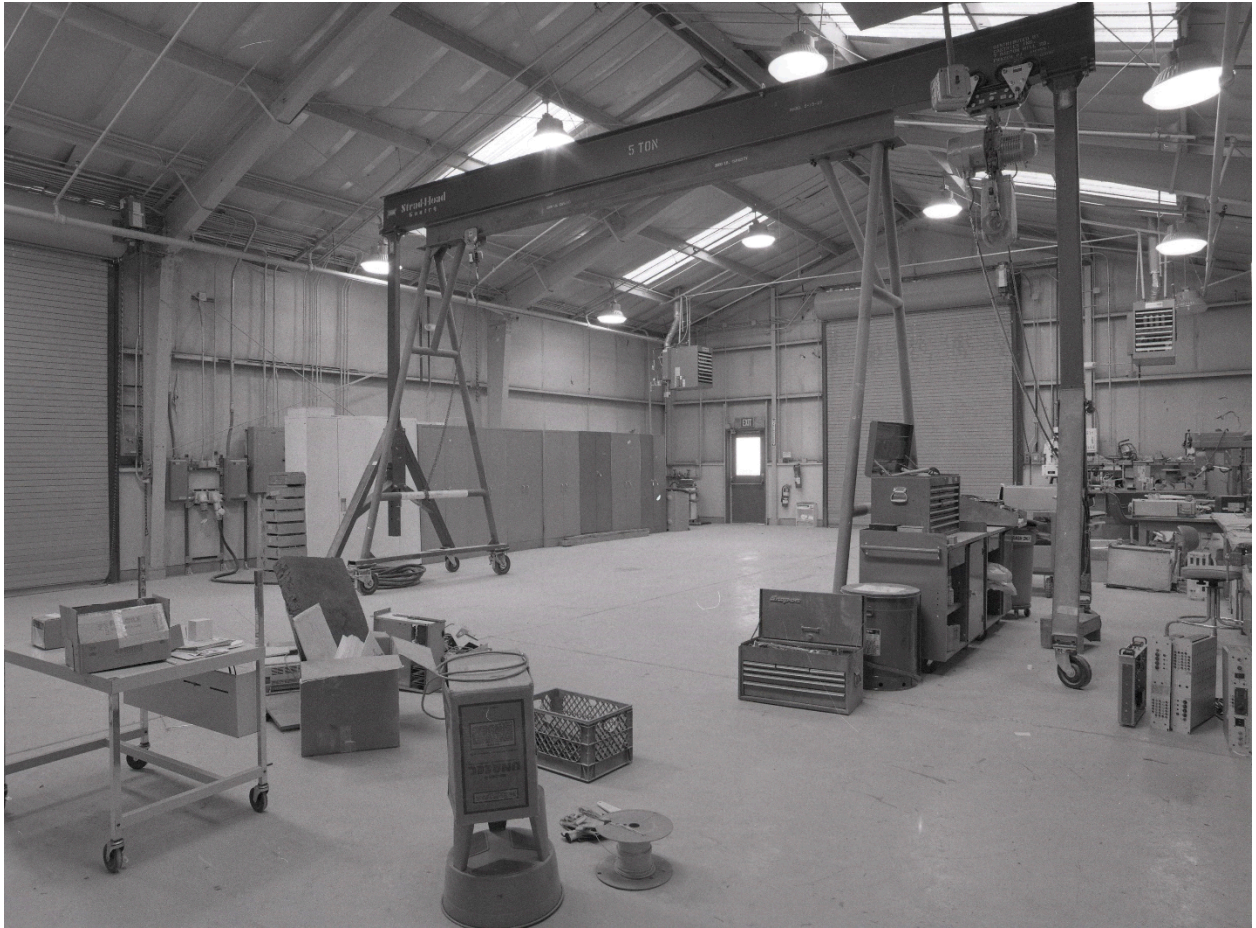
NV-XXXX-7

Jim Galli, Photographer. July 19, 2005.
BUILDING 03-56, INTERIOR; SOUTH AND WEST WALLS
OF HIGH-BAY; ROLL-UP DOORS TO EXTERIOR ON SOUTH
AND WEST WALLS; STEEL FRAMING VISIBLE
THROUGHOUT; CONCRETE FLOOR; WORKTABLES AND
MOVABLE CRANE STRUCTURE; FACING SOUTHWEST

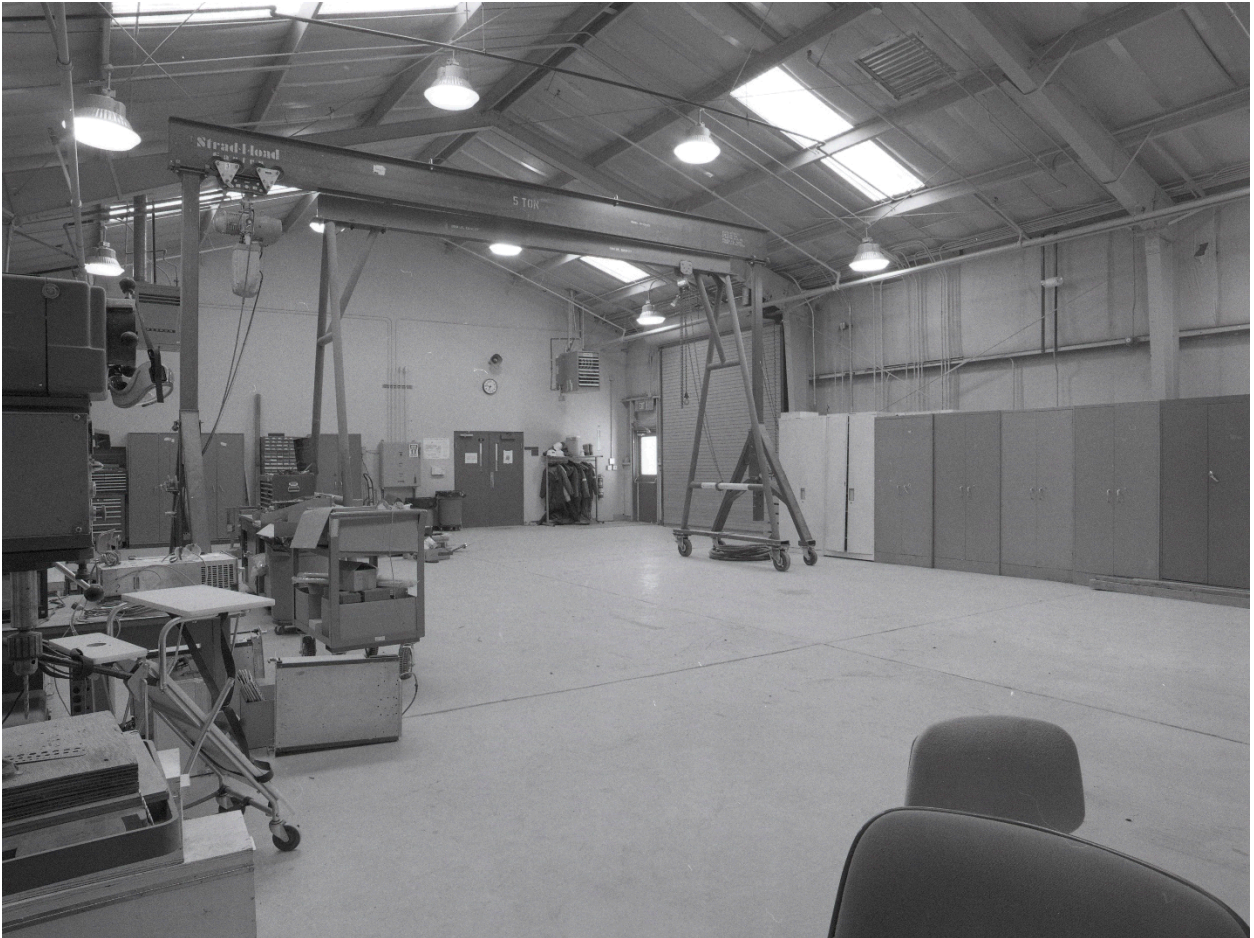
BUILDING 03-56, INTERIOR; EAST AND SOUTH WALLS OF
HIGH-BAY; ROLL-UP AND PEDESTRIAN DOORS TO
EXTERIOR ON SOUTH WALL; DOUBLE DOORS INTO
OFFICE SECTION OF BUILDING ON EAST WALL; FACING
NORTHWEST

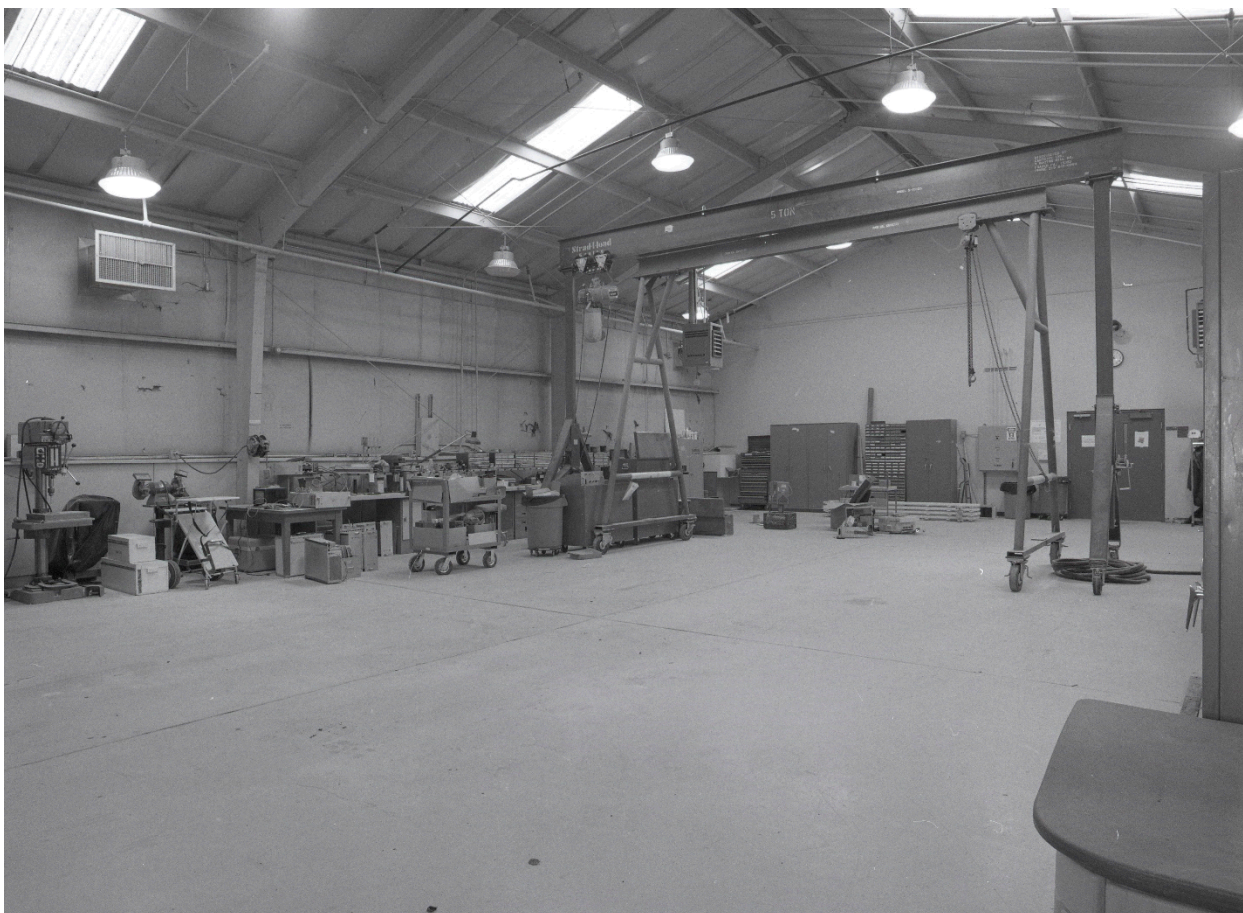
NV-XXXX-9

Jim Galli, Photographer. July 19, 2005.
BUILDING 03-56, INTERIOR; NORTH AND EAST WALLS OF
HIGH-BAY; DOUBLE DOORS INTO OFFICE SECTION OF
BUILDING ON EAST WALL; FACING SOUTHWEST

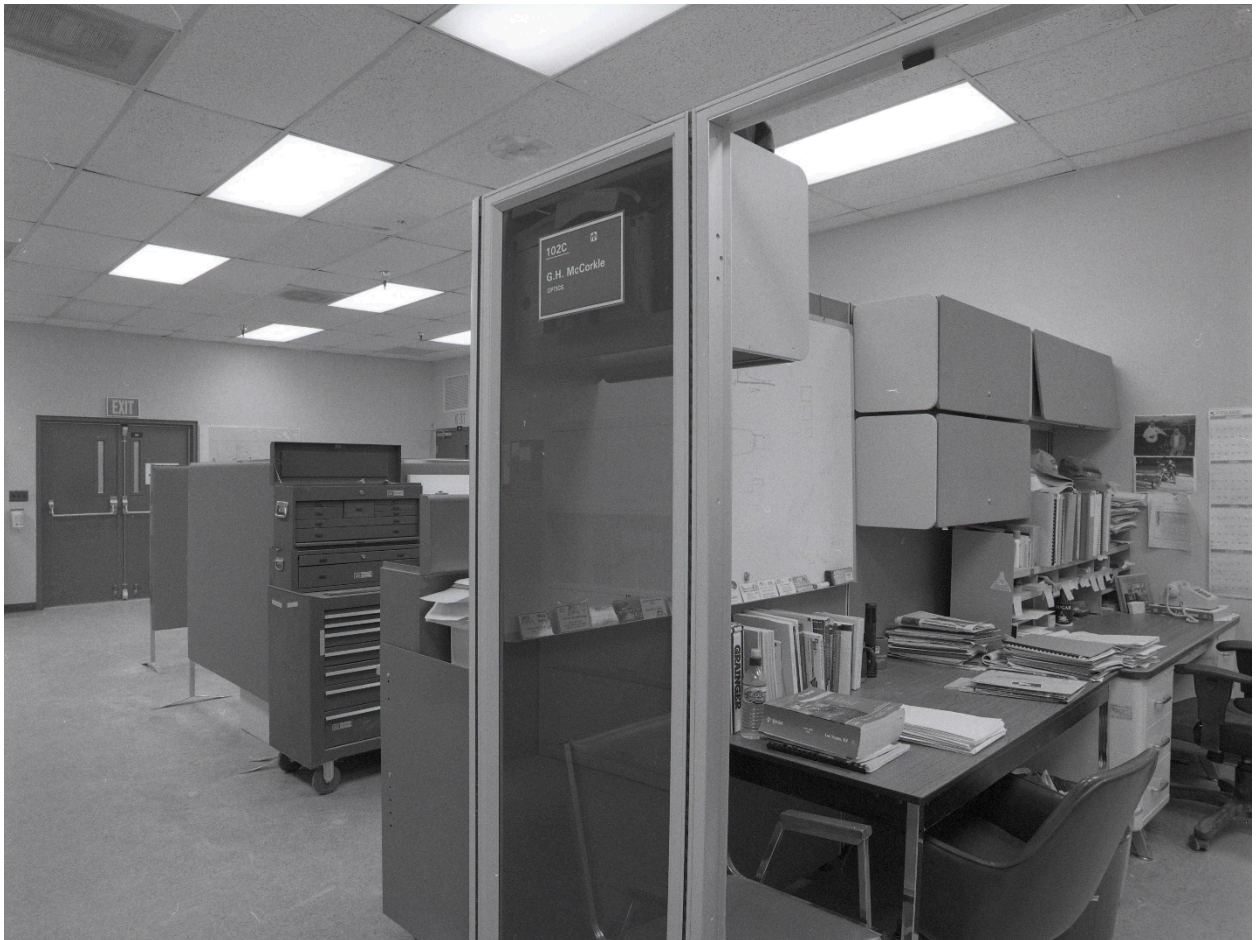
NV-XXXX-10

Jim Galli, Photographer. July 19, 2005.
BUILDING 03-56, INTERIOR; ROOM 102 (SOUTH SECTION)
OF OFFICE PORTION OF BUILDING; DROPPED CEILING;
FLUORESCENT LIGHTING; TILE FLOORS; DOUBLE
DOORS INTO HIGH-BAY ON WEST WALL; FACING
SOUTHEAST

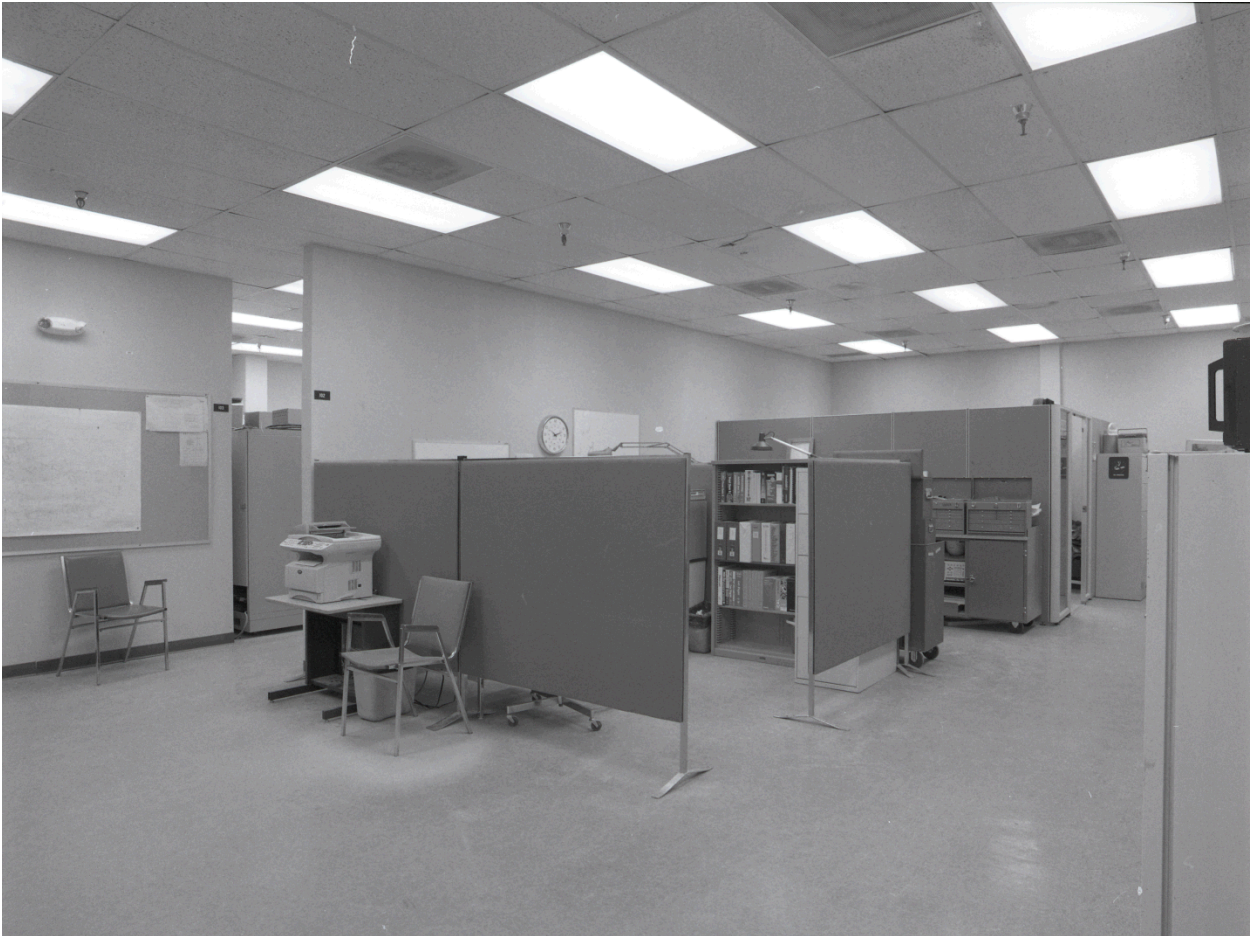
NV-XXXX-11

Jim Galli, Photographer. July 19, 2005.
BUILDING 03-56, INTERIOR; ROOM 102 (SOUTH SECTION)
OF OFFICE PORTION OF BUILDING; WALLS WITH
OPENING INTO ROOM 103 (NORTH SECTION) OF OFFICE
PORTION OF BUILDING; MOVABLE OFFICE PARTITIONS;
FACING SOUTHWEST

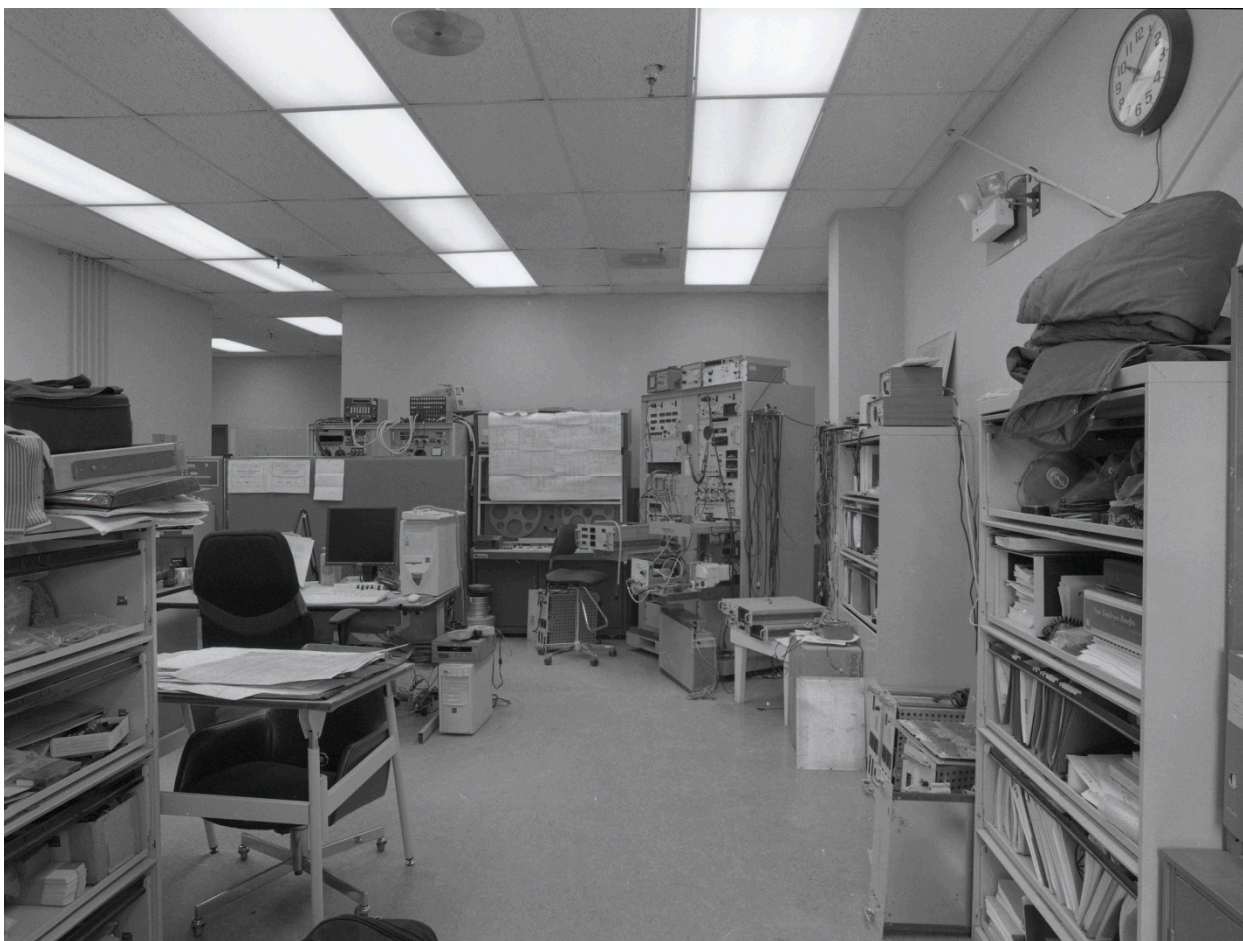
NV-XXXX-12

Jim Galli, Photographer. July 19, 2005.
BUILDING 03-56, INTERIOR; ROOM 103 (NORTH SECTION)
OF OFFICE PORTION OF BUILDING; ALARM SYSTEM
VISIBLE ON NORTH WALL; FACING EAST
